Gaza
Strip
images
of
destruction

Verifying destruction in the southern

Gaza Strip

used by Human Rights Watch to provide verification of the physical condition of sensitive geographic areas within the Gaza Strip.

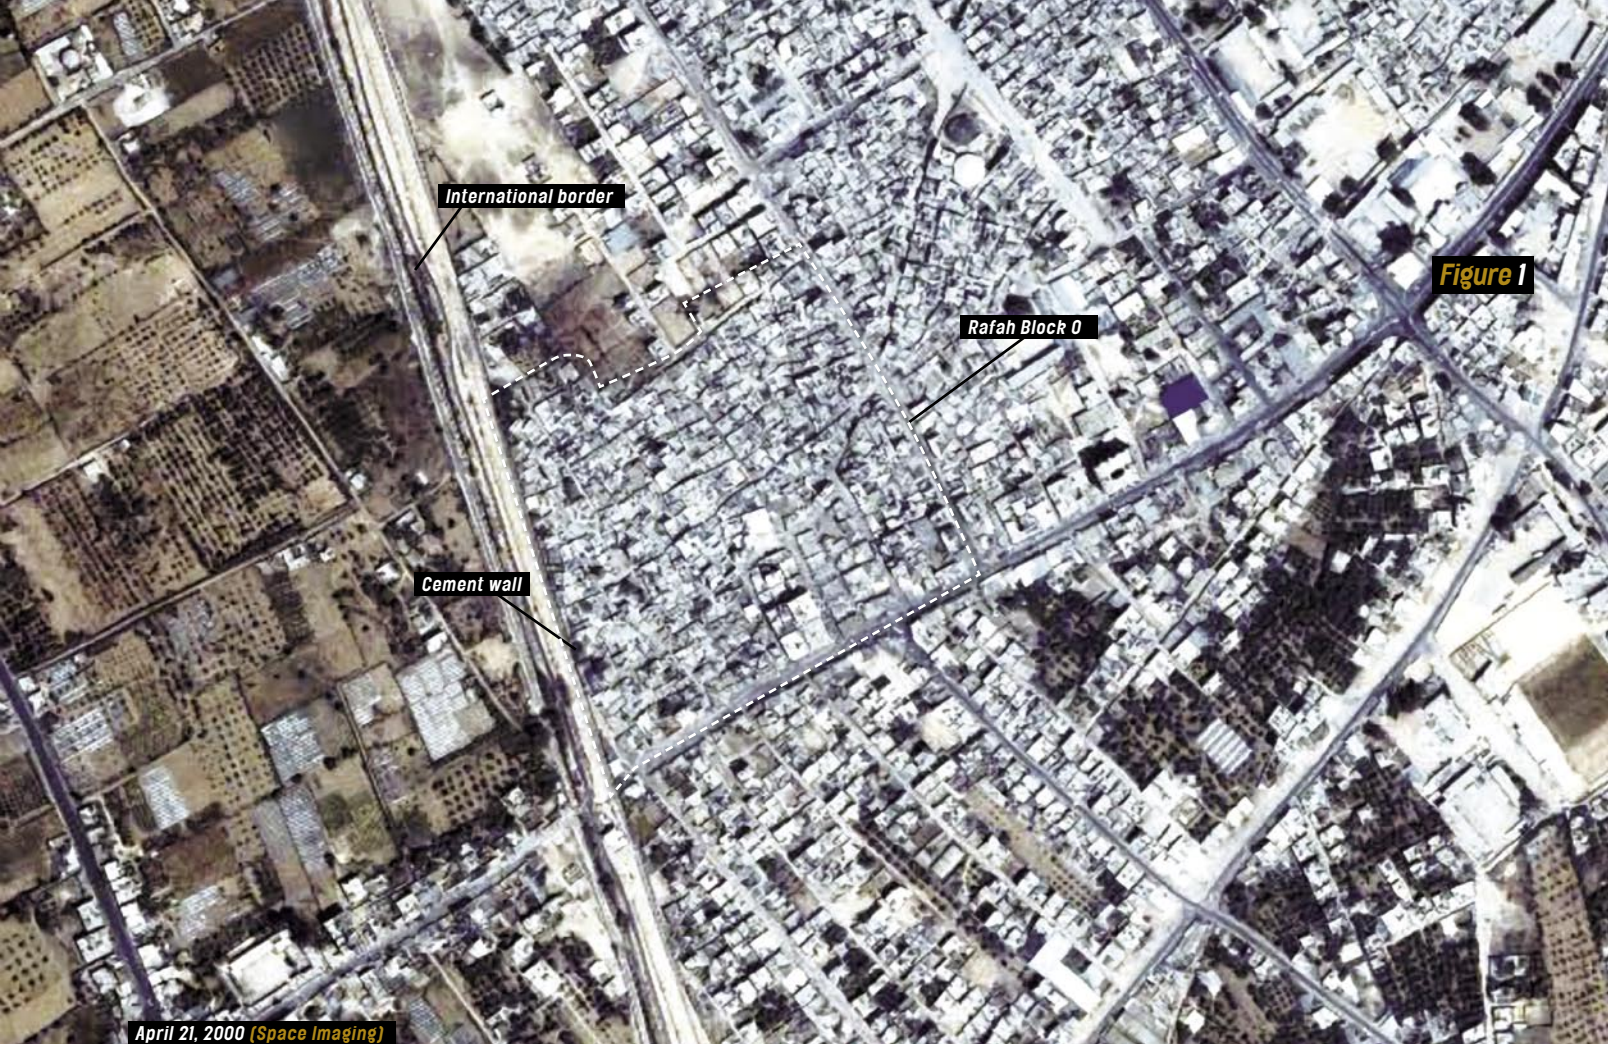
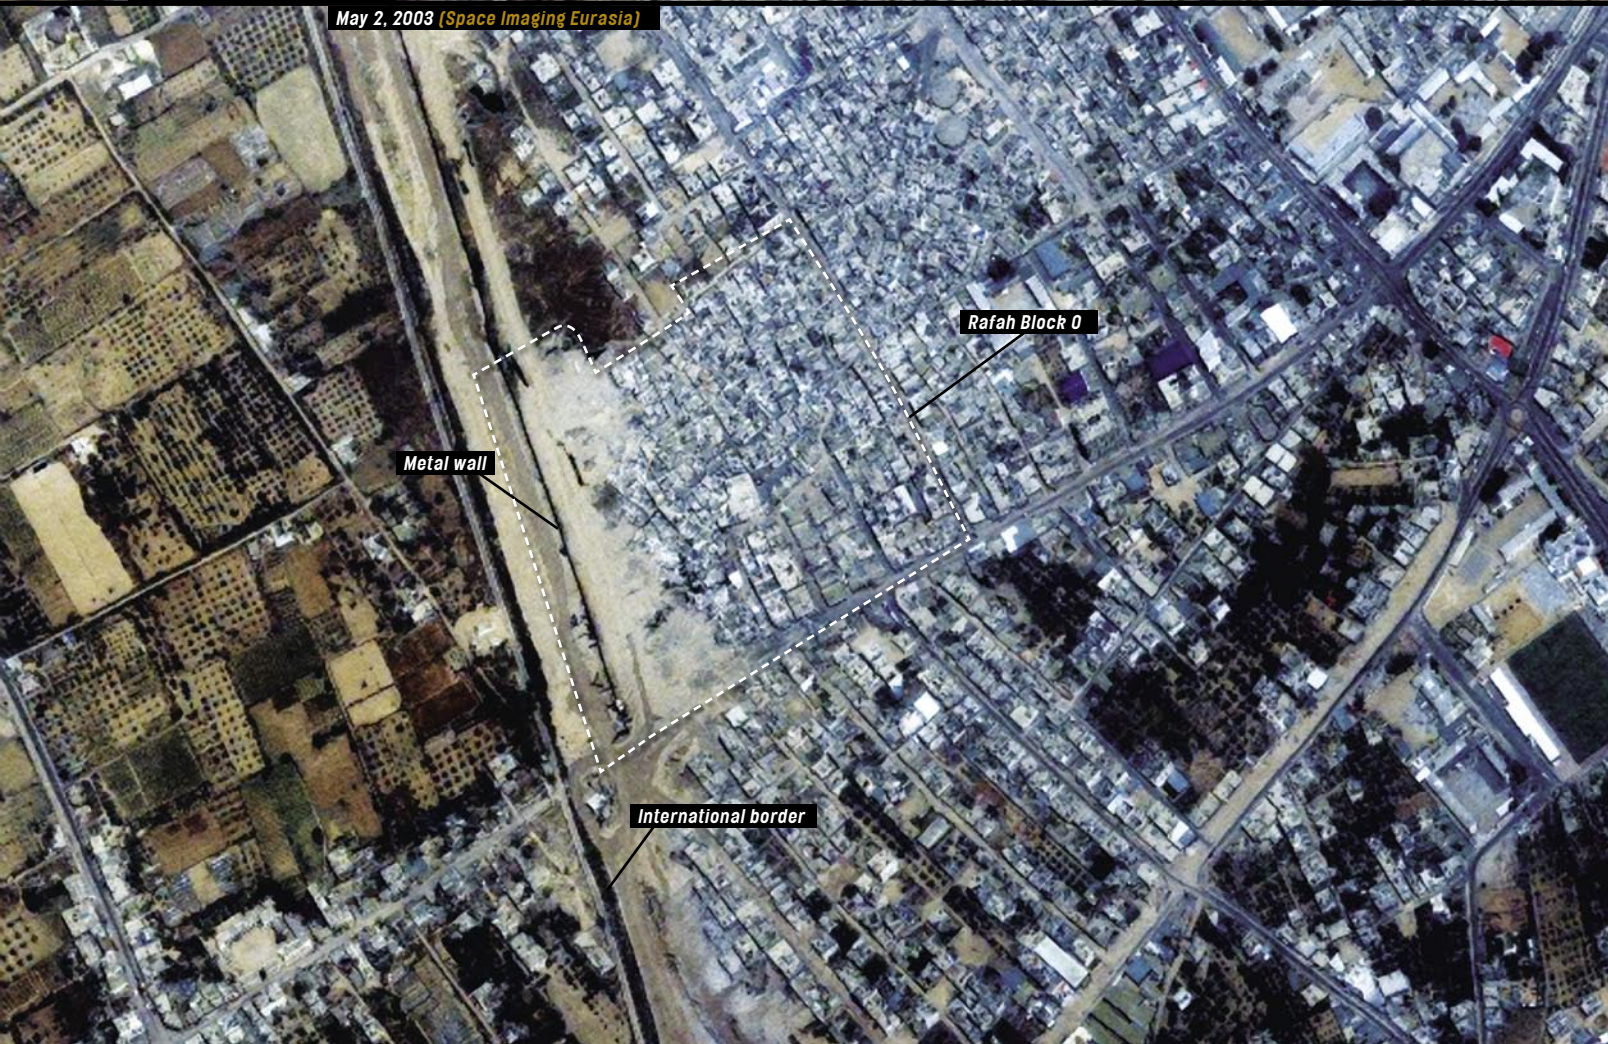
Rafah lies at the center of the 12.5 kilometer-long border between the Gaza Strip and Egypt. It is a dusty city and refugee camp of sprawling concrete homes — one of the poorest and worst-affected areas in the Palestinian-Israeli conflict. The 1979 Camp David Peace Treaty bisected the town between Egyptian Sinai and the Israeli-occupied Gaza Strip, with the result that houses, fields and orchards, at that time, lay very near the border. This was still largely the case in April of 2000, as can be seen in the satellite photograph displayed in **Figure 1 – upper**.

This border area with Egypt is known to the Israelis as the “Philadelphia Corridor” after the IDF designation for the patrol road visible in Figure 1. In 2000 the Philadelphia Corridor was approximately 20 to 40 meters wide, and included a three-meter high concrete wall topped with barbed wire. By May 2, 2003, the corridor was 80 to 90 meters in width (**Figure 1 – lower**).

April 21, 2000 (Space Imaging)

May 2, 2003 (Space Imaging Eurasia)

Beginning in late 2002, after destroying hundreds of homes along the border, the IDF built an eight-meter high metal barrier in front of a long section of the border with Egypt to facilitate the movement of Israeli troops without exposure to hostile fire. This metal wall also extends two meters under ground. The satellite photographs of Figure 1 show Rafah's "Block O," one of the most damaged areas of the camp.

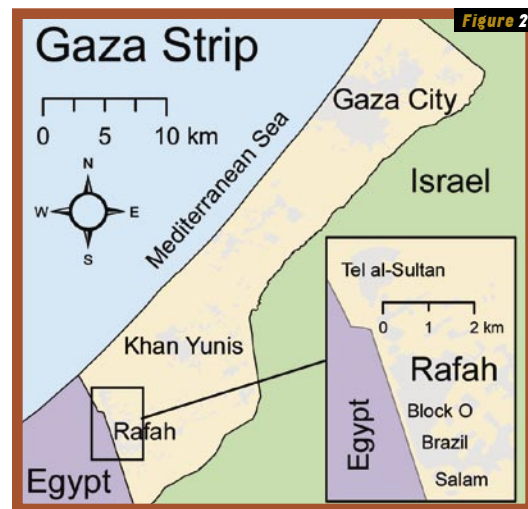
Operation Rainbow primarily targeted two areas: Tel al-Sultan, on the northwest outskirts of Rafah; and the Brazil and Salam neighborhoods, in eastern Rafah, closer to the border (see Figure 2). The IDF did not enter the densely populated center of Rafah. Tel al-Sultan is a newer neighborhood several kilometers northwest of Rafah's center. Israeli forces seized control of Tel al-Sultan on May 18 and imposed a 24-hour curfew. D9 bulldozers extensively tore up roads in Tel al-Sultan, causing severe damage to sewage and water networks. On May 19, a group of several hundred Palestinians marched towards Tel al-Sultan from the center of Rafah, demonstrating against the incursion there. Israeli tanks and helicopters opened fire on the crowd, killing nine people, including five people aged 18 or younger.

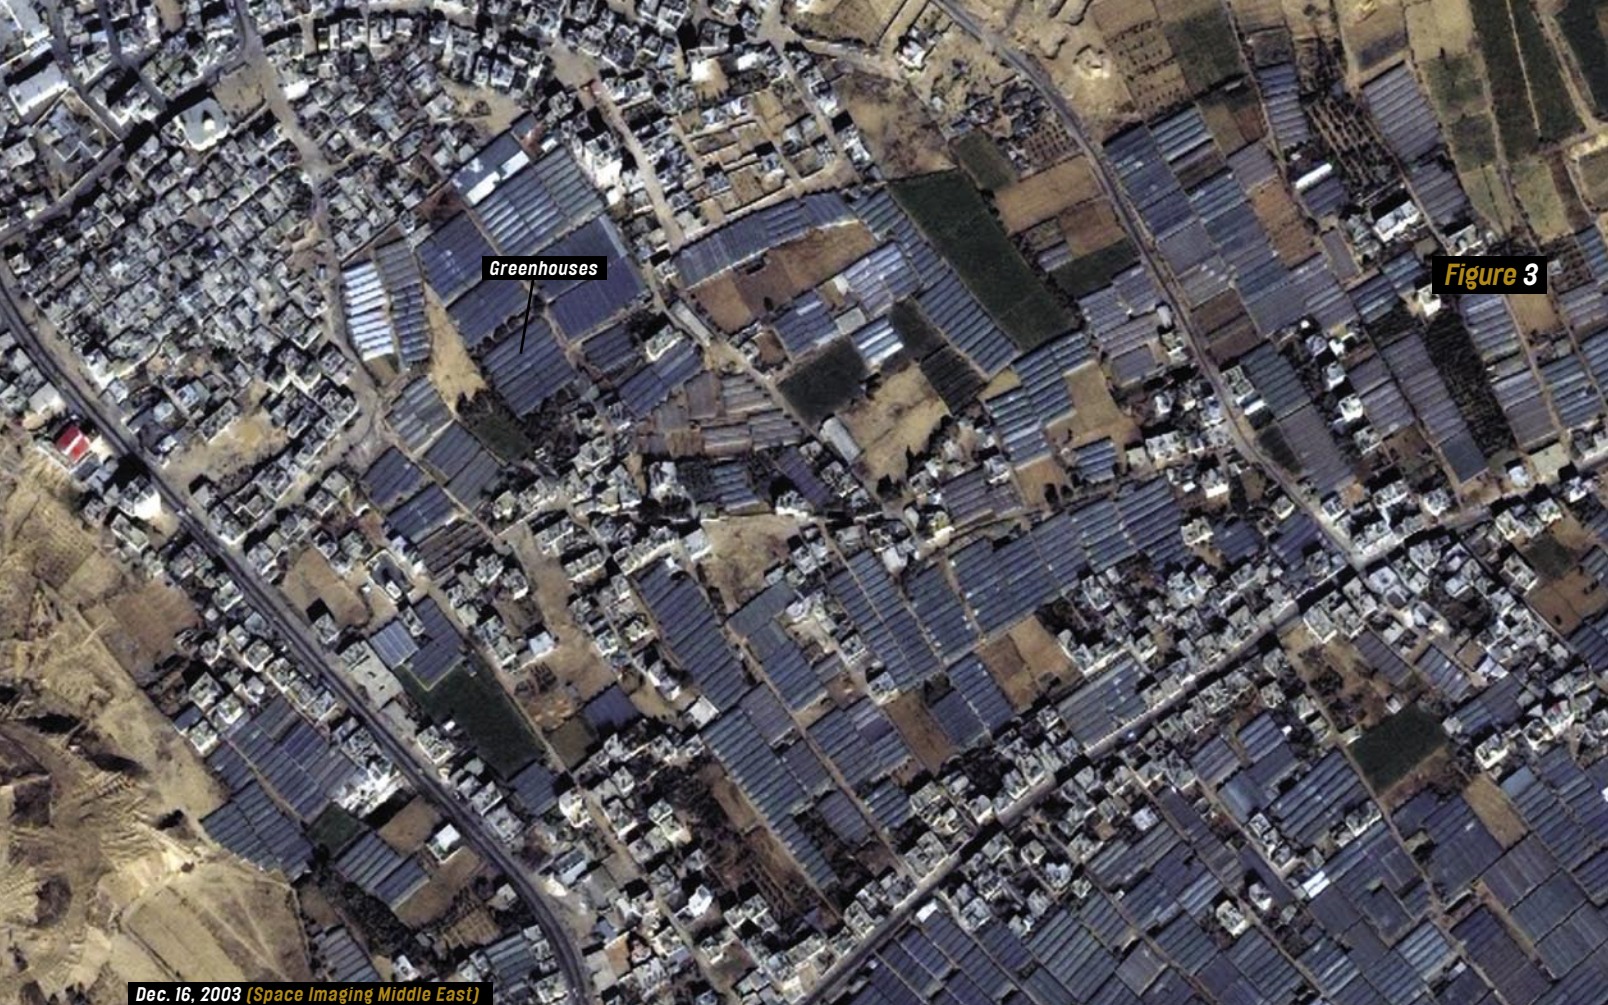
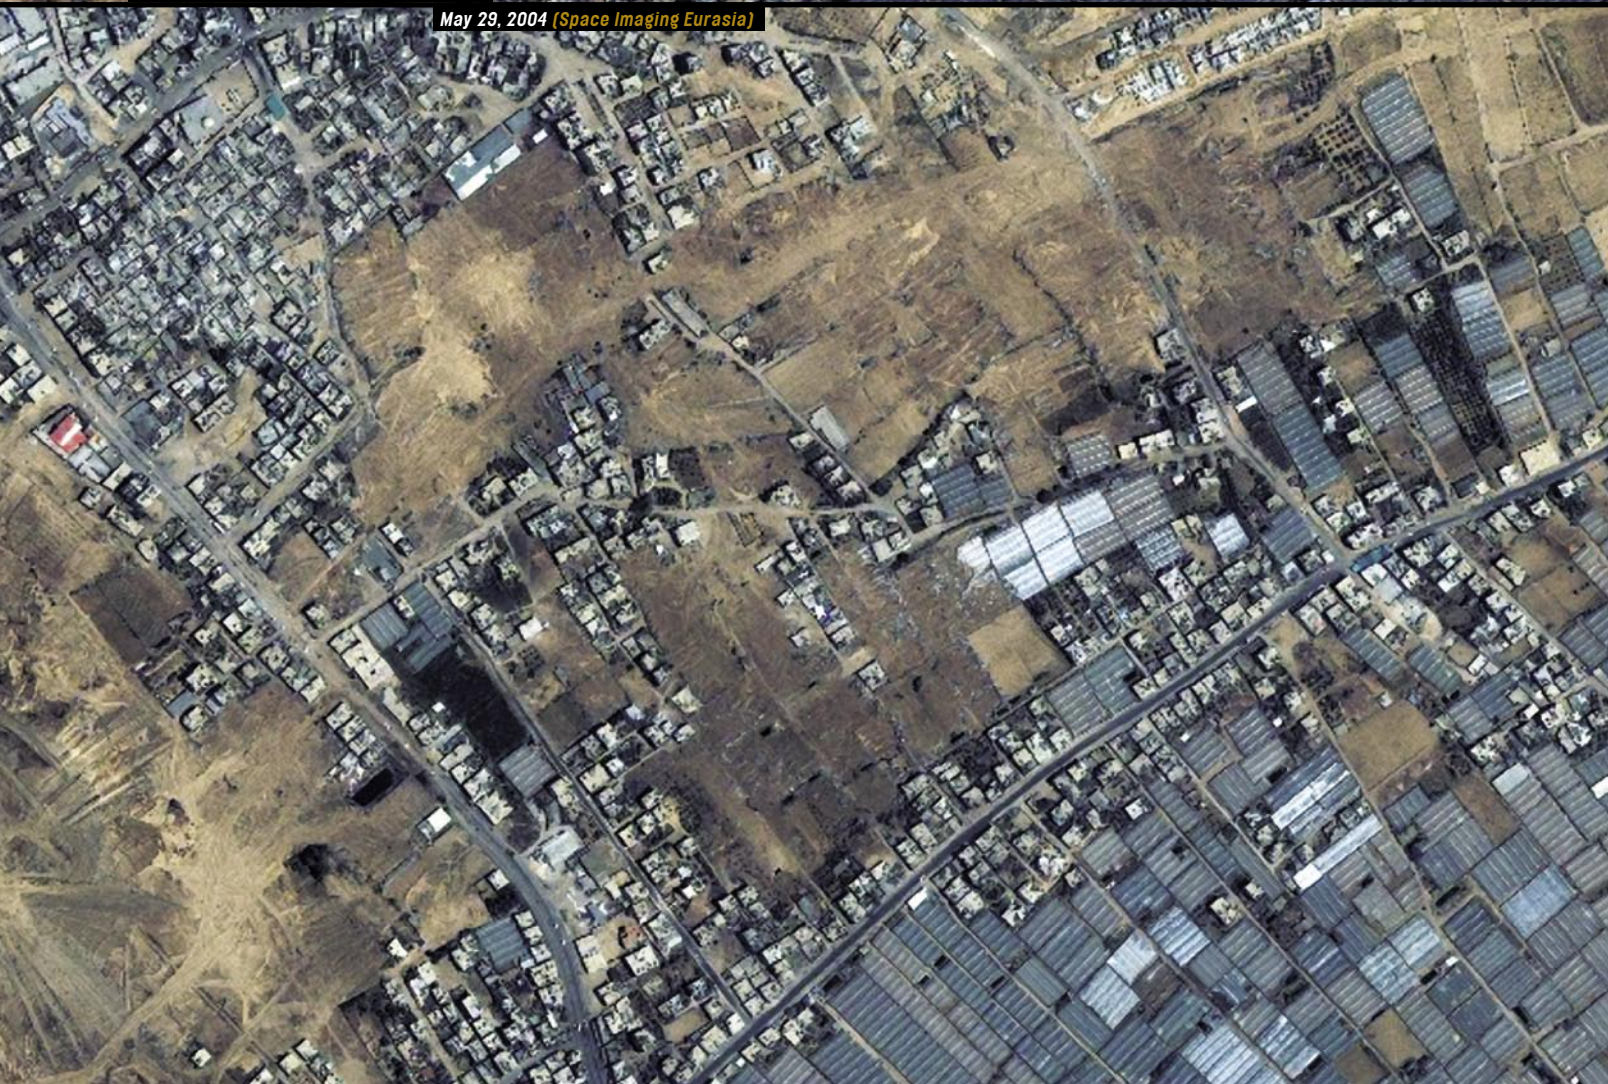
'Ala al-Din Faiz Buraika watched the destruction from his home adjacent to the western-most agricultural area when it began on May 20. "No one could get out or in, tanks were surrounding the area," he told Human Rights Watch. "They surrounded Tel al-Sultan and cut it from the town. They used bulldozers and tanks, with Apaches [helicopters] protecting them from above. They spent three days destroying the greenhouses, which grew onions, melons and flowers." Human Rights Watch inspected both agricultural areas in Tel al-Sultan. Both were devoid of any greenhouses; only ruptured earth littered with metal and glass remains. Figure 3 contrasts before and after satellite images of the agricultural area west of Tel al-Sultan, illustrating this damage.

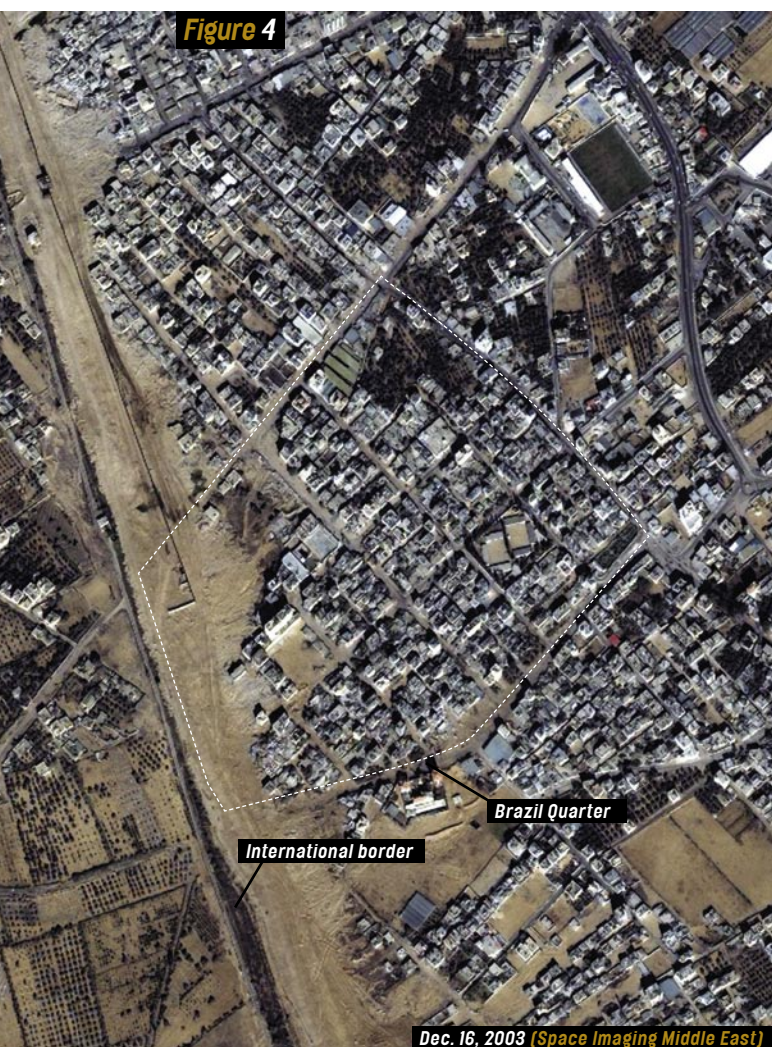
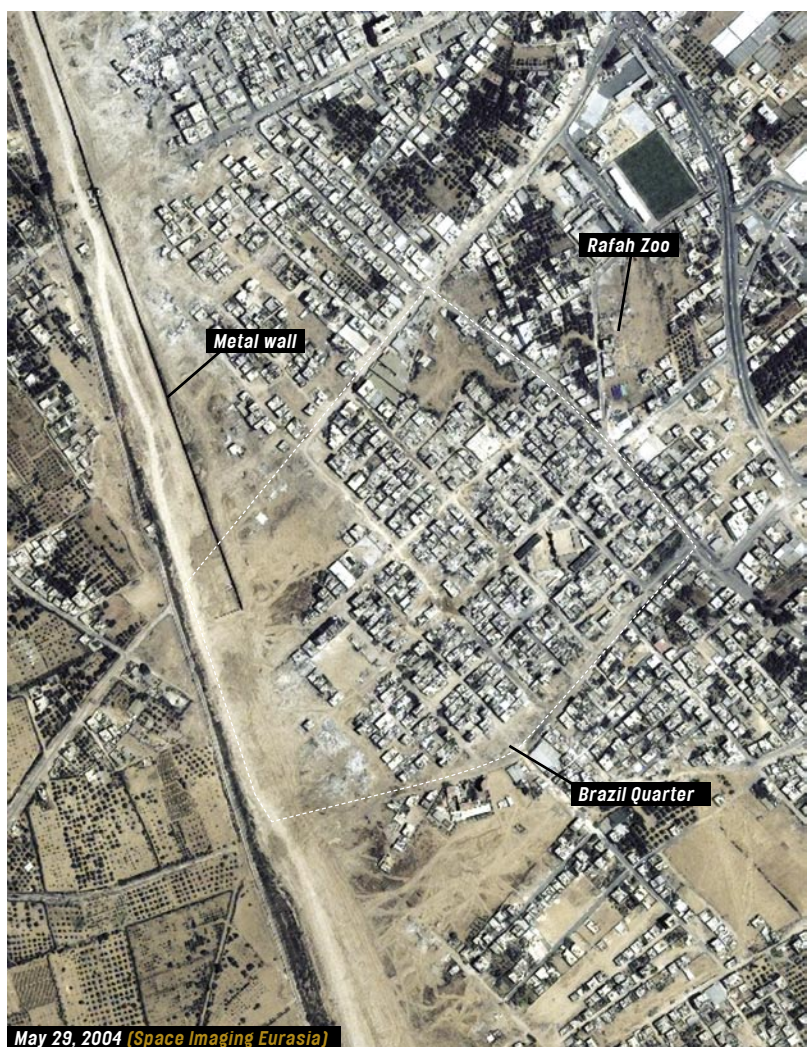
of house demolition are evident in Brazil from the satellite imagery. In the interior of the camp, the IDF bulldozed paths through blocks of one-story houses. Closer to the border, destruction seems to have been more indiscriminate, leveling wider swathes of housing. **Figure 4** contrasts a before and after image of the Brazil quarter. The Rafah Zoo marked the deepest point of penetration into Rafah, where Israeli forces set up a perimeter to isolate Brazil. The demolition continued throughout much of May 20 and resumed periodically until the redeployment of the IDF out of Rafah Brazil on May 24. According to United Nations Relief and Works Agency (UNRWA), the IDF demolished 154 houses in Brazil and Salam.
